LOWER CONNECTICUT RIVER BASIN
HADDAM, CONNECTICUT

SCOVILL RESERVOIR DAM
CT 00431

PHASE I INSPECTION REPORT
NATIONAL DAM INSPECTION PROGRAM

DEPARTMENT OF THE ARMY
NEW ENGLAND DIVISION, CORPS OF ENGINEERS
WALTHAM, MASS. 02154

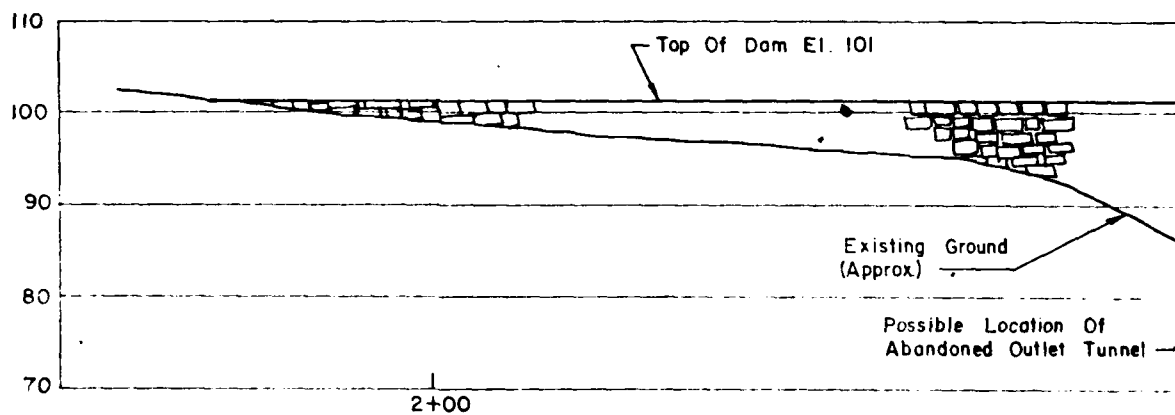
DOWNSTREAM

Outlet Structure Has 4 Grouted Bolts
On Top Of Conc. Surface. This Is An
Indication Of A Previously Removed
Appurtenances To This Structure.
